Broad-Winged Damselfly larvae

# Introduction

The Clinton River runs over 80 miles through Oakland and Macomb counties before draining into Lake St. Clair. Between the length of the river and its sprawling tributaries, the Clinton River watershed covers a very diverse terrain, from farmlands to urban cities. Most large watersheds experience issues such as pollution and flooding, and that is no different in the Clinton. The Clinton River Watershed Council (CRWC) was created over 50 years ago by a council of local governments to address these types of concerns. The first major project undertaken by the council was to collect detailed water quality data from the river, which eventually evolved into Adopt-A-Stream, the volunteer-based water quality monitoring program that CRWC continues to host today.

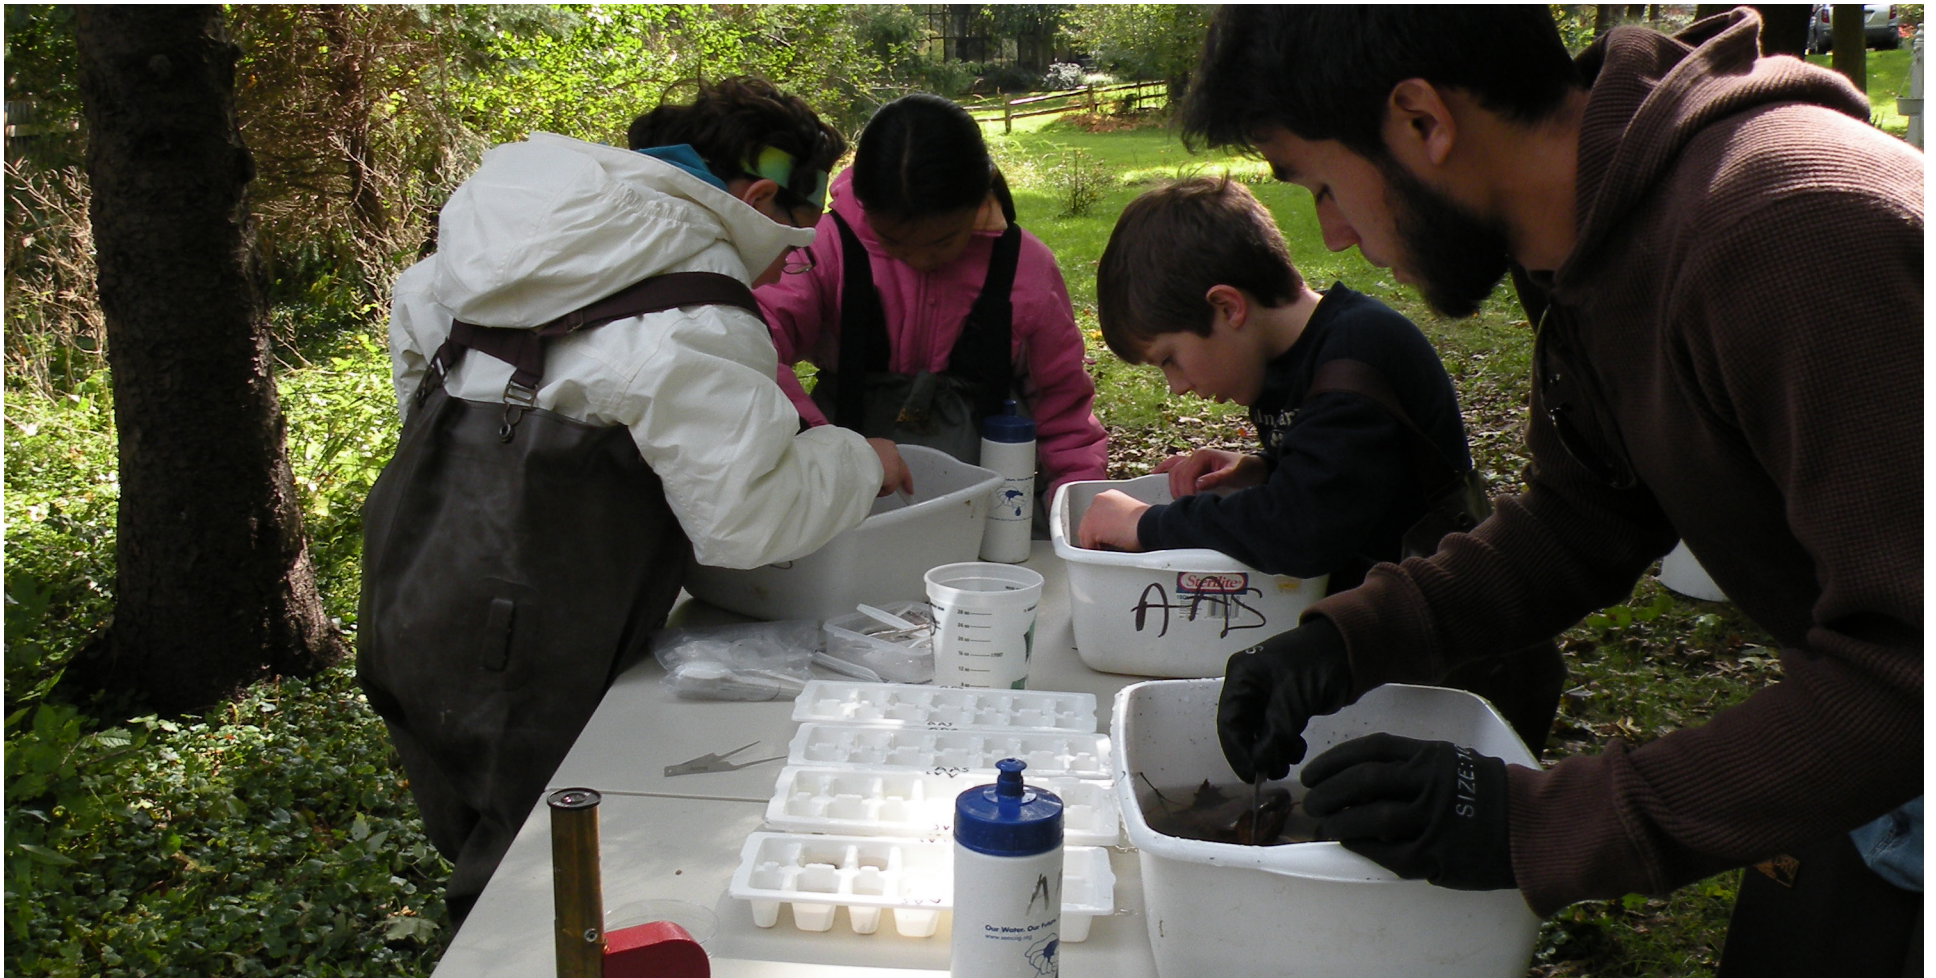
The scores used to discuss water quality are calculated based on the Michigan Clean Water Corps (MiCorps) scoring system. The MiCorps procedure and scoring system were redesigned in 2021 to better align with the commonly accepted tolerance values of macroinvertebrates. Prior to 2021, macros were identified in the field, with a small representative sample submitted for verification. Under the new system, all macros are submitted so that they can be identified to a higher level in a lab, allowing for more accurate results.

However, the new scoring system does include some qualifiers related to abundance. If 31-60 macros are collected, that site automatically is scored "Fairly Poor," and if less than 30 are collected, the site is considered "Very Poor." Many sites scored worse since 2021 than previous years due to the change in procedure. In 2024, CRWC updated materials to help communicate the change and adapted trainings to help demonstrate field techniques that volunteers can employ to collect more macroinvertebrates during sampling.

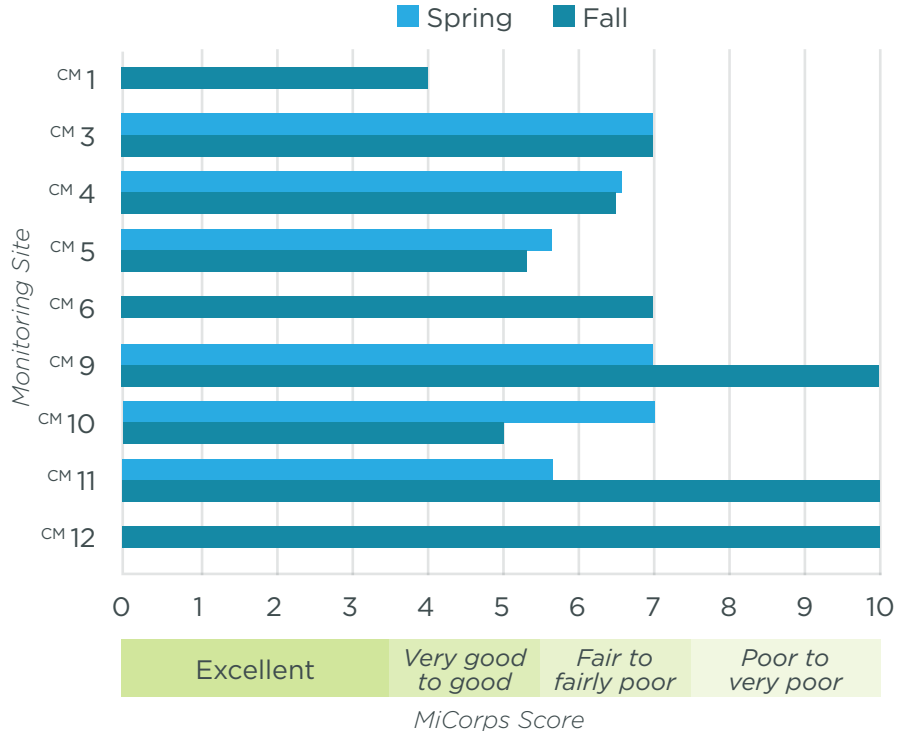
# CLINTON MAIN

The Clinton Main subwatershed, based around the main branch of the Clinton River, is on the West side of the watershed and includes Pontiac, Auburn Hills, and Rochester Hills. Nine sites were monitored in 2023, with six sites directly on the Clinton River, two sites on Galloway Creek, and one on Avon Creek. Site CM10 in Galloway Creek contained the greatest diversity of macros within the Clinton Main subwatershed. There were 14 different families of taxa collected in just one event at this site, including three Ephemeroptera, Plecoptera, and Trichoptera (EPT) families, more commonly known as mayfly, stonefly, and caddisfly. EPT families are useful bio-indicators when looking for pollution.

Scores for these sites ranged from “Very Good” to “Very Poor,” with most falling between “Fair” to “Fairly Poor.” Many sites were given an automatic score of “Fairly Poor” or “Very Poor” based on abundance alone, but the composition of the bugs that were found is indicative of better scores. CRWC believes that in 2023’s data, the amount of macros collected isn’t entirely representative of the abundance of bugs that can be found at that site. CRWC hopes to improve collection efforts in 2024.

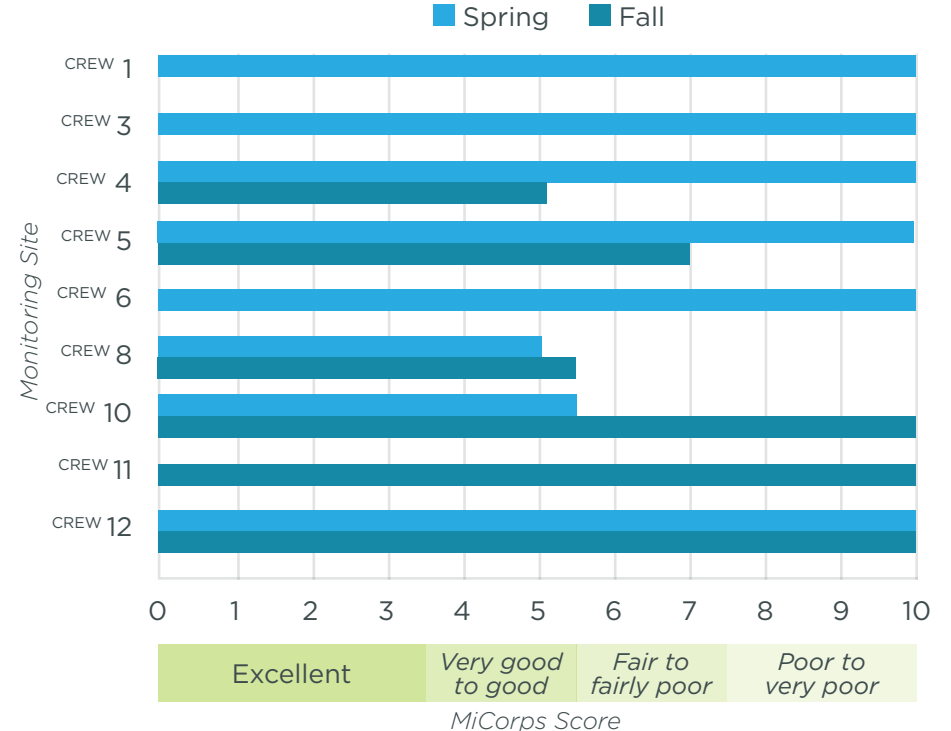
# CLINTON RIVER EAST

The Clinton River East subwatershed (CREW) is just east of the Clinton Main and includes both the main and middle branches of the Clinton River, from where they enter Macomb County until they reach Lake St. Clair. This subwatershed spans as far north as Bruce Township, down to Fraser, encapsulating a wide variety of land usages. Sites are established on the main and middle branches of the Clinton River as well as at Utica Drain, Price Brook Drain, Gloede Drain, and Kuku Creek for a total of 9 sites in this subwatershed. The best score, falling under “Good,” was found at CREW 8, which monitors Price Brook Drain in Shelby Township.

Just like the Clinton Main subwatershed, many sites in the Clinton River East subwatershed had their scores adjusted due to abundance, with most sites falling into the “Very Poor” scoring range. Some of the sites suffer from unstable or low-quality habitat, which could also have contributed to low abundance. Other sites’ fall scores are believed to have been primarily influenced by significant rain events.

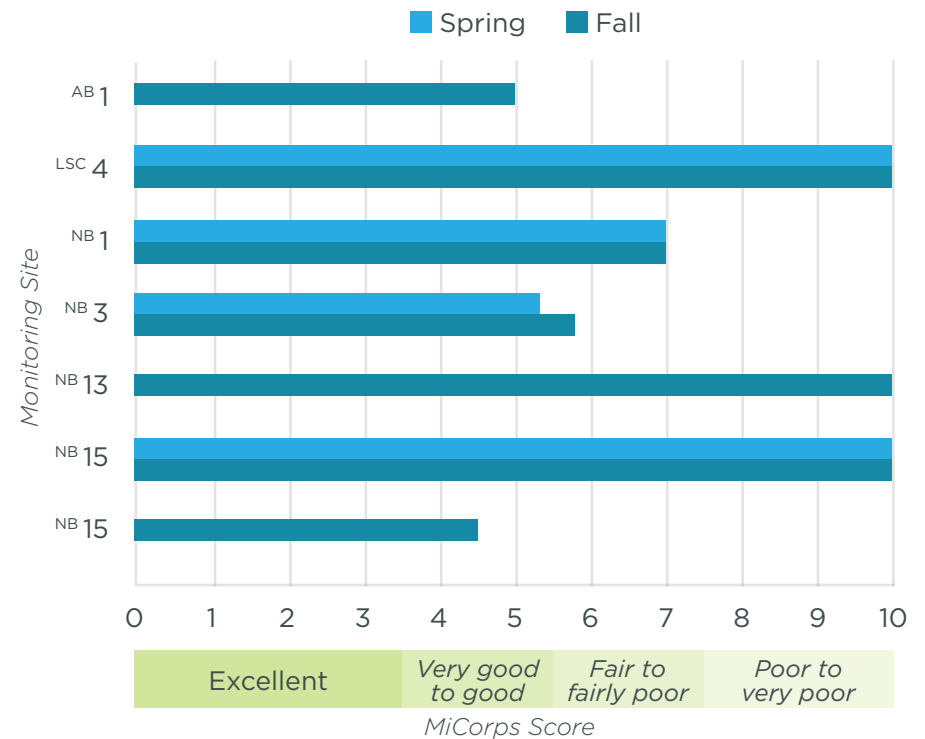
# ANCHOR BAY, LAKE ST. CLAIR DIRECT DRAINAGE, & NORTH BRANCH

The North Branch of the Clinton River runs through the northernmost parts of the watershed in Leonard and Almont, eventually meeting with the main branch in Mt. Clemens. The land use in this subwatershed is primarily agriculture, which leads to some unique issues relating to stormwater, including the introduction of fertilizers into the waterways. In addition to the three monitoring sites along the North Branch, sites are also established at East Coon Creek and McBride Drain. Many sites faced issues with the abundance of macros collected in 2023.

Site NB1, which monitors the North Branch at Wolcott Mill, had four sensitive families collected in the spring, which would traditionally lend itself to a “Very Good” score, however, the site was still scored as “Fairly Poor” due to the total abundance. The North Branch as a whole was scored in the “Fairly Poor” range due to abundance. Historical data and the bugs found suggest most sites would have fallen into the “Good” range if abundance criteria had been met.

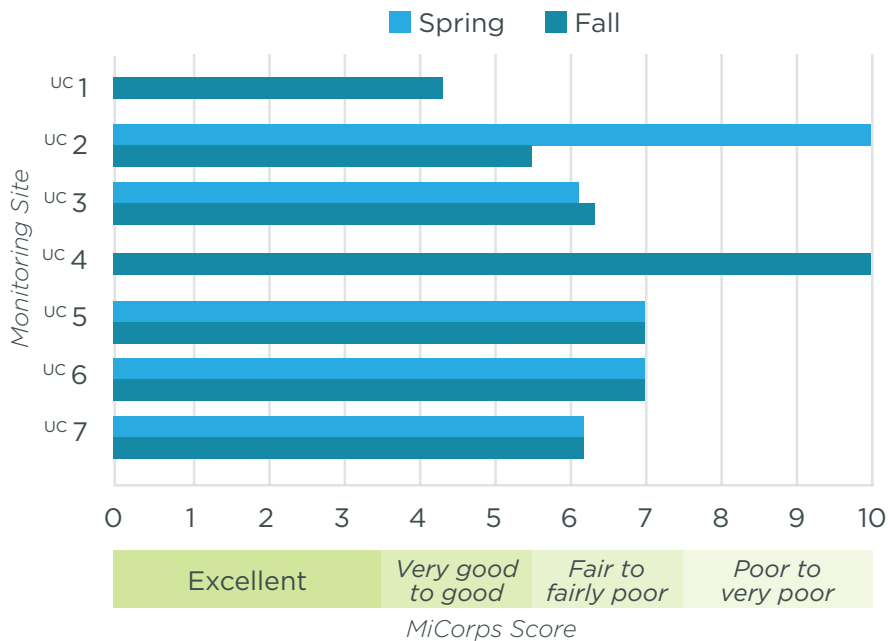
# UPPER CLINTON

The Upper Clinton subwatershed surrounds the headwaters and chain of lakes that start the Clinton River. It's important to monitor the headwaters because they influence the rest of the river system. Six sites in this subwatershed monitor the Clinton, while the remaining site monitors Sashabaw Creek. This year's best-scoring site in this subwatershed, UC1, monitors the Clinton River in Independence Township; this site received a "Very Good" score! A large number of net-spinning caddisflies were found here in 2023. Sashabaw Creek (UC3) only received a "Fair" score, even though it contained the largest diversity of bugs found across all sites in 2023, with 32 families collected in fall 2023. This diversity of life is a testament to the stability of the habitat in the wetlands surrounding the Upper Clinton.

The headwaters typically score relatively well due to the lack of accumulation of pollution, but scores averaged on the lower side in 2023 due to the abundance collected. Abundance was lower in the Fall across most sites, and it is believed that the rain leading up to the monitoring date affected results. Overall, Upper Clinton sites averaged a "Fairly Poor" rating in 2023 but have the potential to score in the "Good" range based on species found.

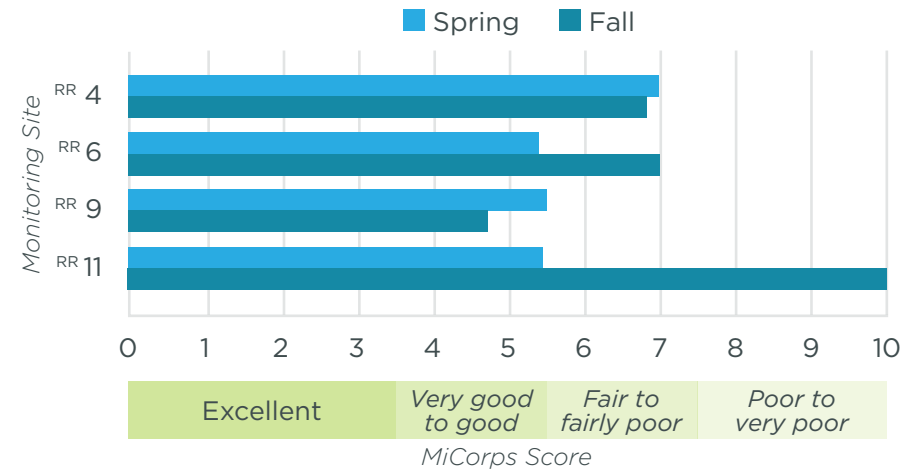
# RED RUN

The Red Run subwatershed covers some of the most developed areas within the Clinton River drainage basin, surrounding the Red Run. Developed areas have more impervious surfaces than undeveloped land, which can lead to flashy waterways that are prone to sudden changes during precipitation events. The Red Run also tends to collect a large amount of stormwater runoff. The Red Run itself is very large and deep, so the four monitoring sites in this subwatershed are on Big Beaver Creek, Chrissman Drain, and Plumbrook Drain, all of which lead to Red Run. During the spring monitoring, some sensitive mayflies and damselflies were found in Chrissman Drain (RR6). Sensitive mayflies have been found at this site for many years, which is an indication of a stable habitat.

While overall, the Red Run sites averaged in the "Fairly Poor" range in 2023, the sites are showing improvements from prior years. This could be partially due to the clean-up efforts happening at these sites, removing trash that had accumulated over decades, allowing for habitat improvements to naturally occur.

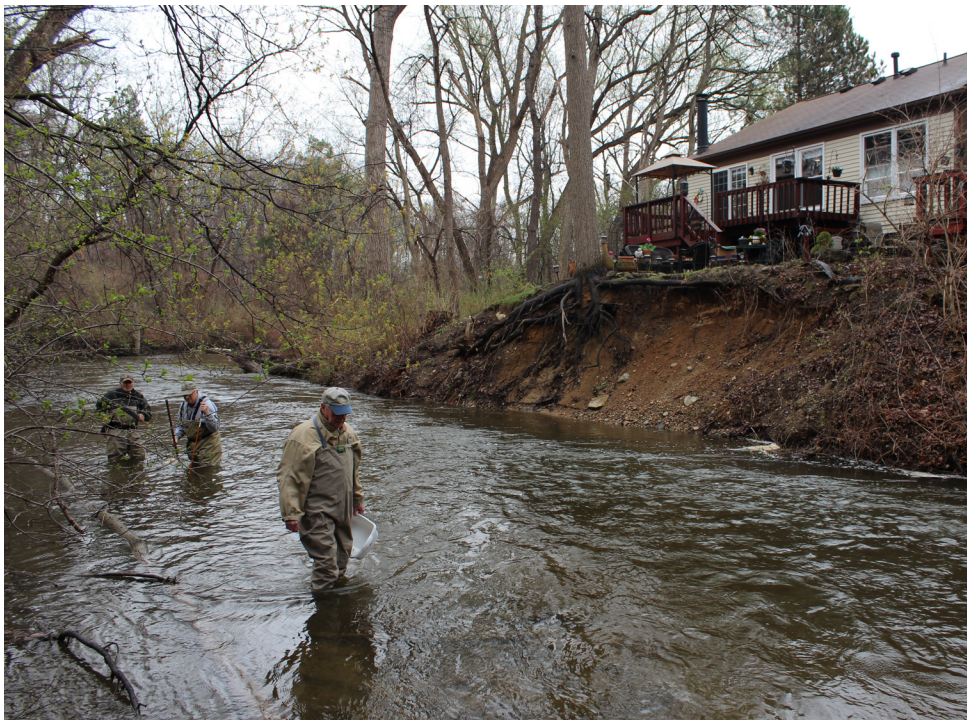
# STONY & PAINT CREEKS

Stony Creek and Paint Creek are two high-quality creeks that feed into the Clinton River, forming the Stony/Paint Creek subwatershed. This subwatershed is largely rural, forested land, which provides the creeks with extra protection from pollution. Because Paint Creek is one of the last remaining coldwater trout streams in Southeast Michigan, it's a priority for monitoring. Of the 13 sites monitored in 2023 in this subwatershed, 7 sites monitor Paint Creek, 5 sites monitor Stony Creek, and 1 site monitors Gallagher Creek.

Site SP15, which monitors Stony Creek at VanHoosen Farms, scored the best out of all sites monitored in 2023, falling on the high end of the “Very Good” range. A dragonhunter dragonfly, notable for being very sensitive to pollution, was caught at Stony Creek in Washington Township, making that the second verified collection of that species within Macomb County. Overall, sites ranged from scoring “Very Good” to “Very Poor,” with all the “Very Poor” ratings stemming from abundance qualifiers. Based on the families collected at these sites, we expect most sites to fall between “Fair” and “Good” with a greater sample size of bugs.

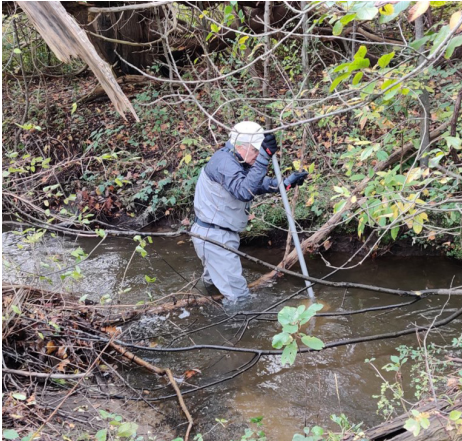
## RIVER CONDITIONS

With the large number of sites that CRWC monitors, we rely on volunteers to report back on site conditions that may not be included in the datasheet. From water levels to construction to invasive species, the notes and photos our volunteers collect are important to understanding these sites over time. From these reports, CRWC can investigate sites that may need remedial action.

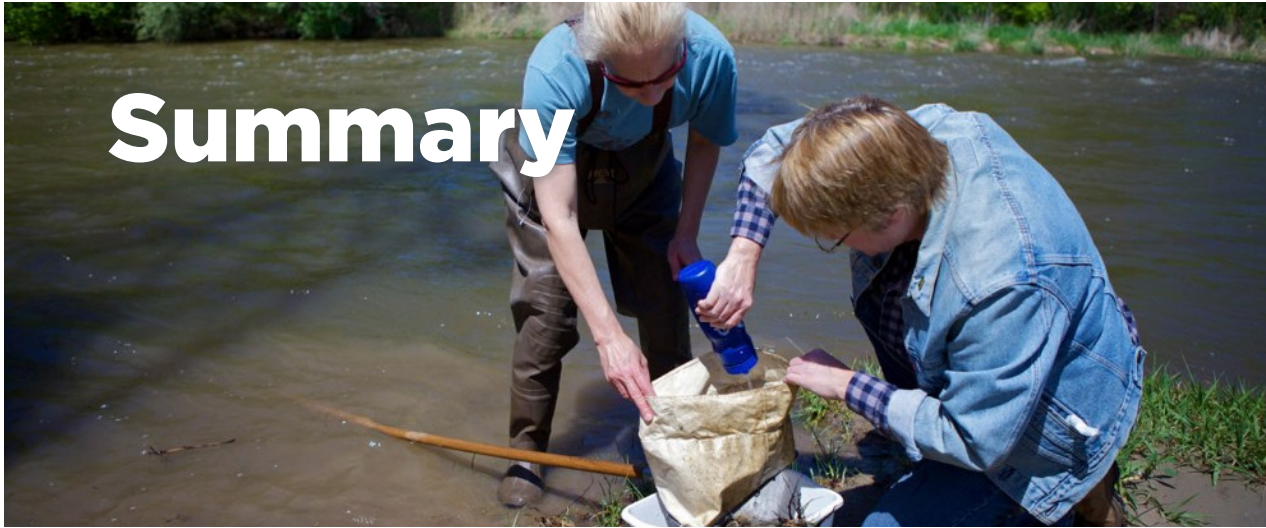
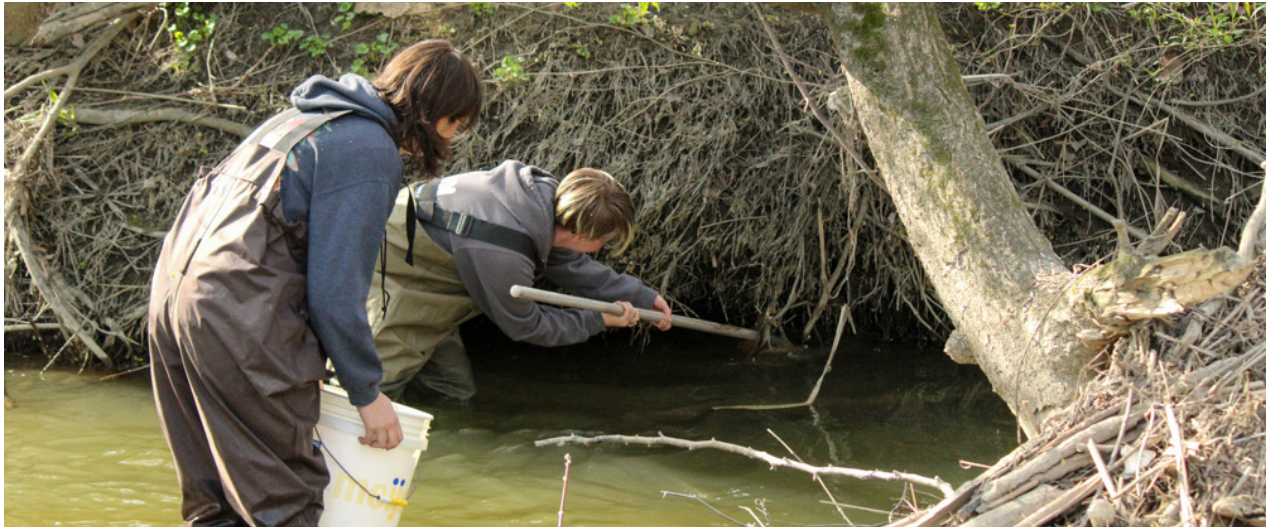
# Summary

Overall in 2023, 49 total sites were monitored across the watershed, which is a notable improvement from 2022, in which 39 sites were monitored. More than 4,700 bugs were collected across the watershed. Collected bugs were comprised of 90 different families, 17 of which are very sensitive to pollution. True to historical data from the region, midges (Chronomidae), scuds (Amphipoda), and net-spinning caddisflies (Hydropsychidae) were CRWC's most common finds. Despite the issues with the abundance of macros collected, over 1/3 of our sites showed positive trends, which is on par with previous years. CRWC hopes that as volunteer trainings and sampling procedures are adjusted to meet new MiCorps scoring guidelines, site scores will more accurately represent life and water quality within the Clinton River watershed.
