# THE CLINTON RIVER WATERSHED MANAGEMENT PLAN

NORTH BRANCH  
CLINTON RIVER  
SUBWATERSHED

## *The Unified Subwater and Site Reconnaissance* for the North Branch Clinton River Watershed (2009)

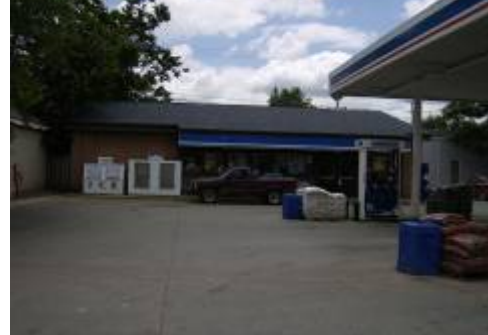
**Figure 19: Typical Impervious Surface**

- C1 – Eighteen (18; 72%) of the neighborhoods had mostly impervious driveways (80% + of households).
- C2 – Twelve (12; 50%) of the neighborhoods were clean, nine (9; 39.5%) were in disrepair (breaking-up), and ten (10; 41.6%) were either stained or dirty. (These are not mutually exclusive categories).

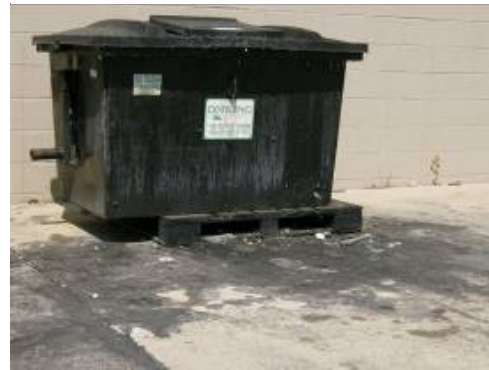
**Figure 22: Garbage Dumpster**

Commercial dumpster had the greatest problems with six (6) having no covers, four (4) were damaged, two (2) were leaking and one (1) was overflowing. Municipal dumpster exhibited similar problems.

D-3 - Only three (3) dumpsters were in a storm water drain inlet area, two (2) of which failed to provide diversion measures for the storm water.

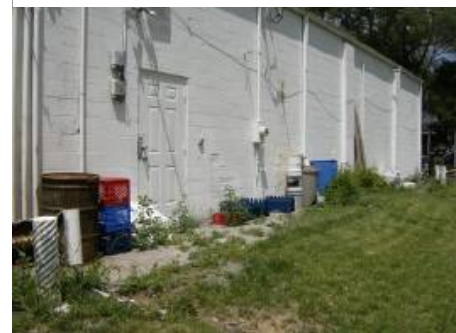
**Figure 23: Material at Rear of Commercial Site**

- Three (3; 14%) buildings displayed evidence that current maintain practices resulted in discharges to the storm drain.

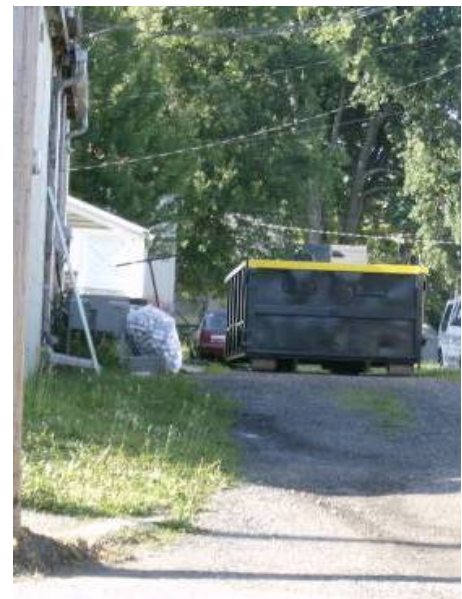
**Figure 24: Outdoor Storage Area**

Most of the outside storage areas are associated with commercial land uses (13). Nine (9) stored liquids and one solid storage area were covered. Five (5) other sites with outside storage areas were allied with municipal land uses, two of which stored liquids and one stored solids. The one (1) industrial site had outside storage for solid material and there was one transport-related outdoor site. Eleven (11) outdoor storage areas were on concrete/asphalt and eight (8) were on grass/dirt.

C3 – Nine (9; 45%) outside storage areas were directly or indirectly connected to storm drains. One site you could not tell.

C4 – Twelve (12; 60%) outdoor storage sites exhibited staining that suggests potentially polluting discharges have occurred at sometime in the past.

C7 – Nine (9; 45%) outdoors sites appeared in poor condition and existed missing labels, rusting, etc. Seven did not exhibit poor conditions. It was not possible to determine the site conditions at two sites.

Outdoor storage areas were problematic. Almost half were directly connected to storm drains, and over half exhibited staining and were in generally poor condition. On the positive side, over 70% of sites observed with outside storage had both secondary containment and/or a cover. Similar results were reported for waste management on sites. Both outdoor storage and waste management can be associated with any of the above surveyed land uses.

- 1) Implementing an education initiative targeted at commercial/retail, and industrial businesses (it is assumed that the Phase II permit will address the municipal sites). Education should focus on vehicle, material, and waste management and for storm water protection.
- 2) Initiating a beautification program targeted at local business that incorporates storm water management facilities and reduces impervious surfaces.
- 3) Both items 1 and 2 should be priorities by areas in close proximity to connected water features and % impervious surface in the vicinity.

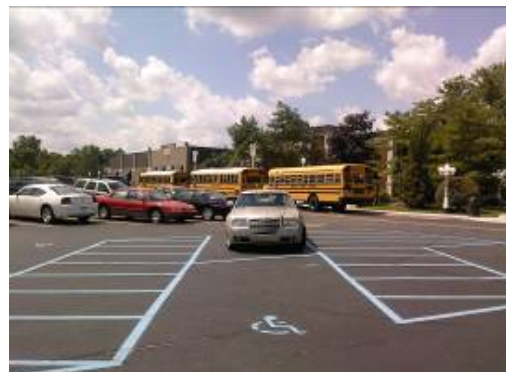
**Figure 26: Parking Lot**

LAND USE	CONDITION				Total
	Clean	Dirty	Stained	Damaged	
Commercial	3	8	9	5	25
Industrial	0	1	1	1	3
Institutional	1	0	0	0	1
Municipal	0	1	1	3	5
Transport-Related	0	0	1	1	2
Total	4	10	12	10	36

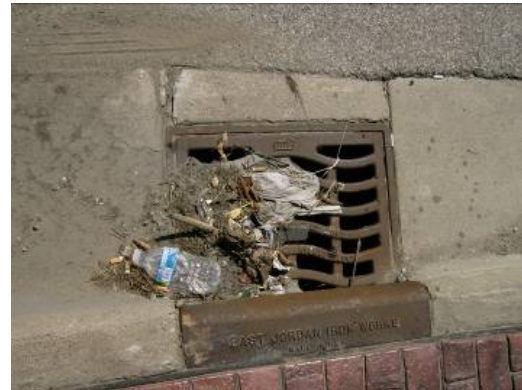
**Figure 31: Street Debris**

The most apparent problems observed was that organic matter accumulated at 62% of the sites. Litter and sediment accumulation were also observed to be an issue at 31% and 33% of the sites respectively. Almost all sites have access for a vacuum truck.

- 1) Prioritize street sweeping and catch basin cleaning on State Trunklines, County Primary, and City Major roads (total of 459 miles) so the most heavily used receive additional cleanings.
- 2) Expand education on stormwater, especially the stenciling program in residential neighborhoods.
- 3) Continue to enforce the SESC requirements for new construction.
